Manhole Inspection Summary

Manhole # S25YY_020MH

Location Address: **3300 CLIPPER RD**

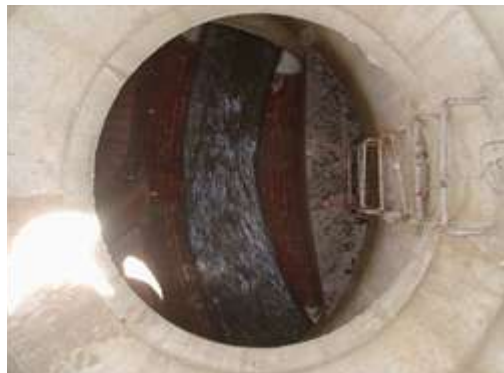
Top View

Corroded and missing steps. Bench debris.

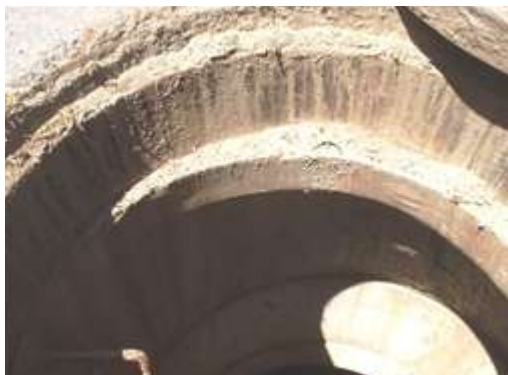
Defect

Frame leaks. Frame offset. Adjustment, Corbel and Barrel infiltration - other side.

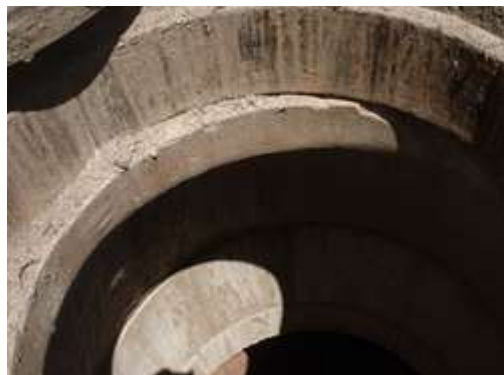
Defect

Frame leaks. Adjustment, Corbel and Barrel infiltration.

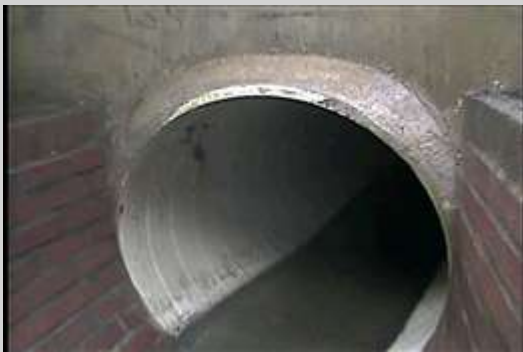
36 in. Circular Gravity Sewer Pipe Out @ 12 O'Clock

Invert Depth: **14.20** (ft.) Flow Characteristics: **Fast**

Infiltration: **None** Pipe Seal Cond: **Unknown**

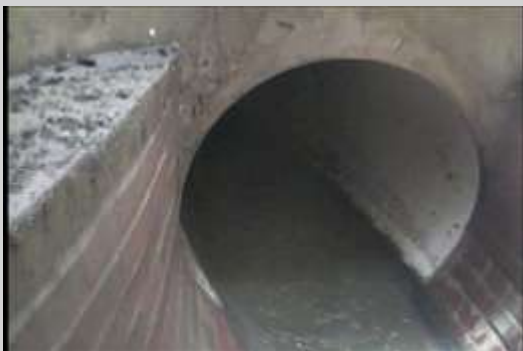
36 in. Circular Gravity Sewer Pipe In @ 5 O'Clock

Invert Depth: **13.90** (ft.) Flow Characteristics: **Fast**

Infiltration: **None** Pipe Seal Cond: **Unknown**

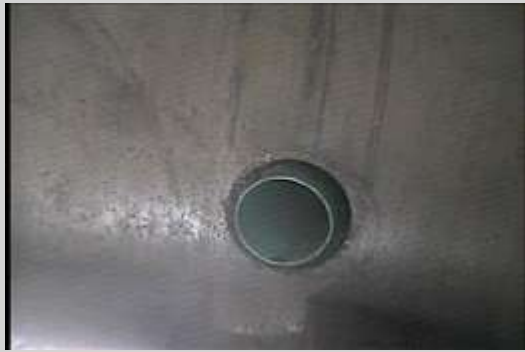
Pipe In @ 8 O'Clock

Invert Depth: **12.20** (ft.) Flow Characteristics: **None**

Infiltration: **None** Pipe Seal Cond: **Unknown**

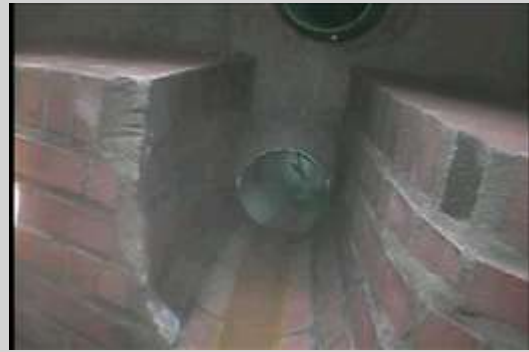
Drop In @ 8 O'Clock

Drop: **Outside** Rod and Bar

Angled: **Yes** Reading: **12.10** (ft.)

Inv Depth: **13.10** (ft.)

Drop Condition: **Open**
